Materials Sciences Corporation

MICROMECHANICAL EVALUATION OF
CERAMIC MATRIX COMPOSITES

Technical Final Report
MSC TFR 2201/1506
February, 1991

Contract No. F49620-88-C-0069

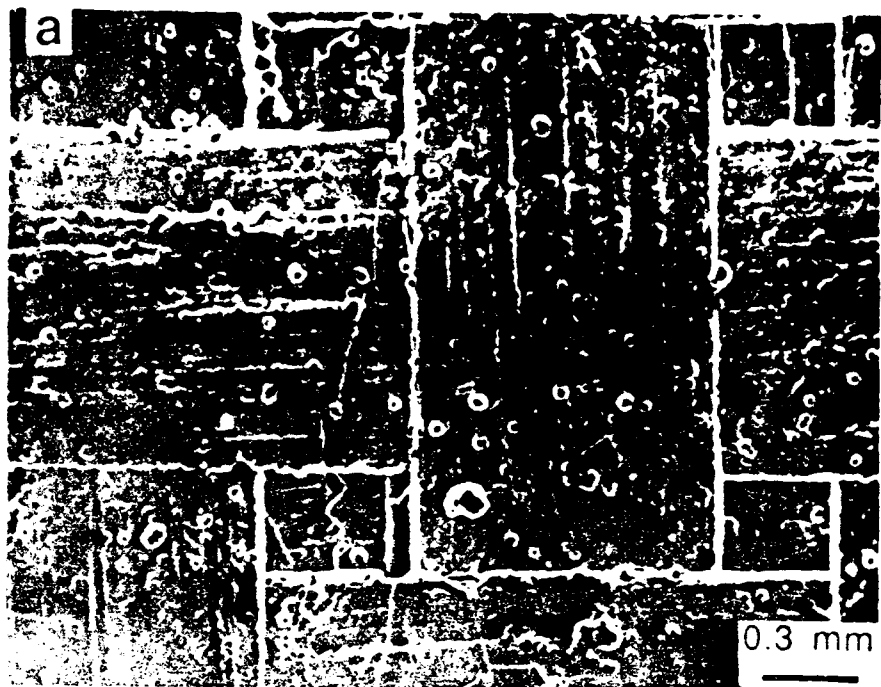
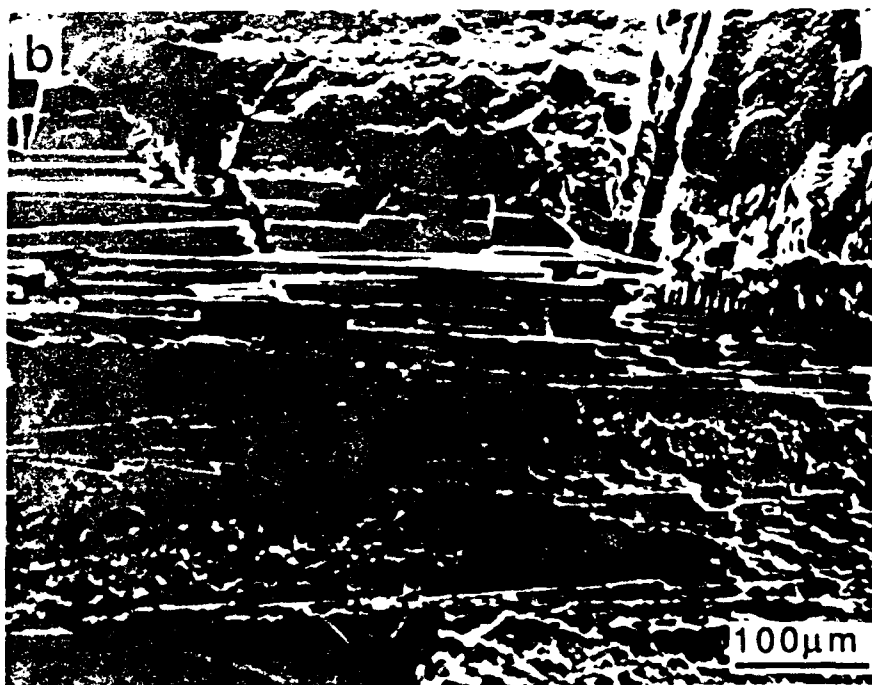
Figure 27. The Same Area as That Shown in Figure 14 After Loading in Tension to 4469 N (1000 lbs)

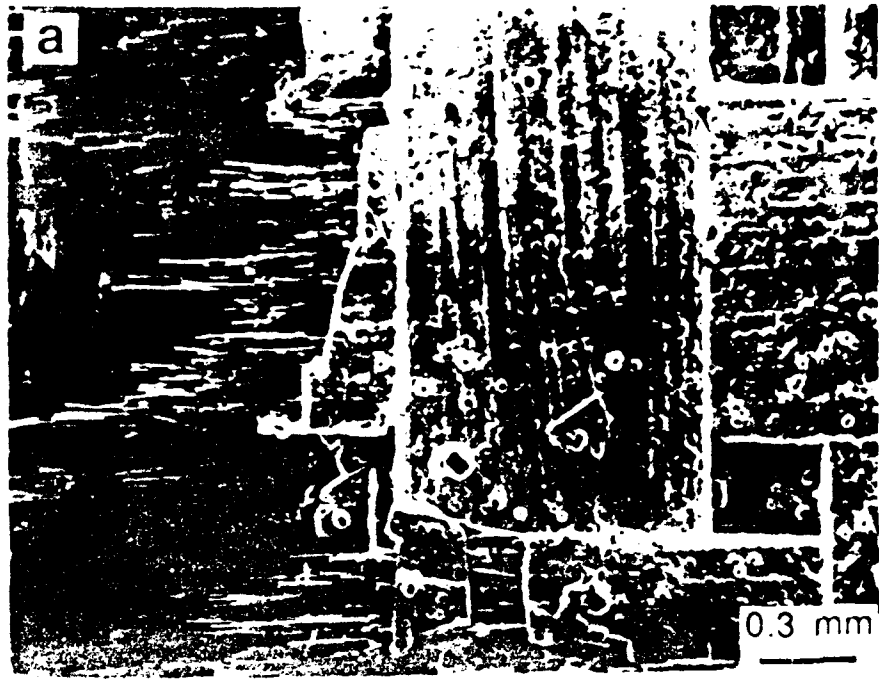
Figure 28. The Appearance of the Specimen After Fracture at 6256 N (1400 lbs); the Same Area as in Figures 14 and 15 is Shown

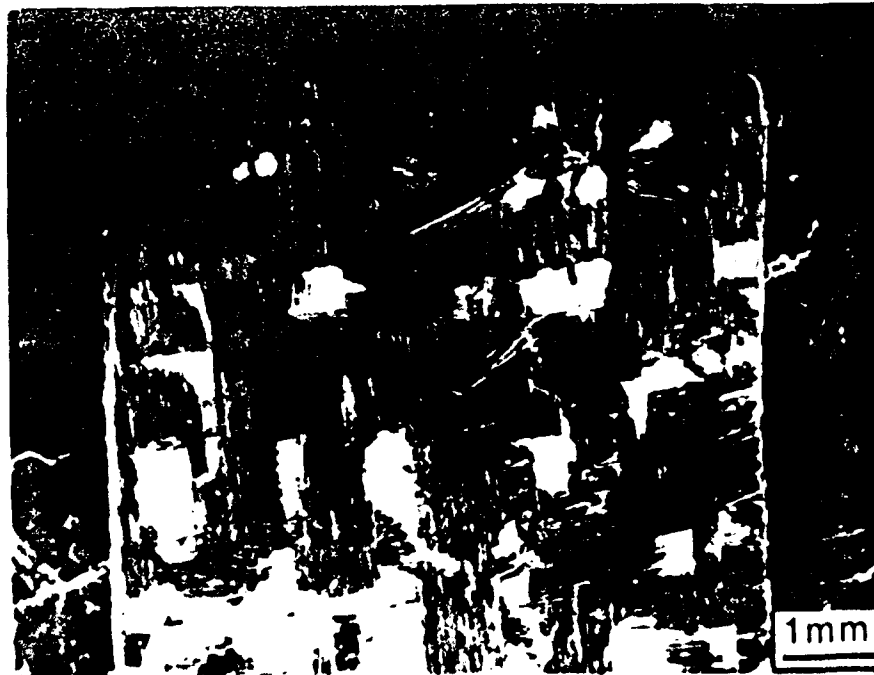
Figure 29. Macroscopic View of the Fracture Surface of a C/SiC Cross-Weave Composite Failed in Tension

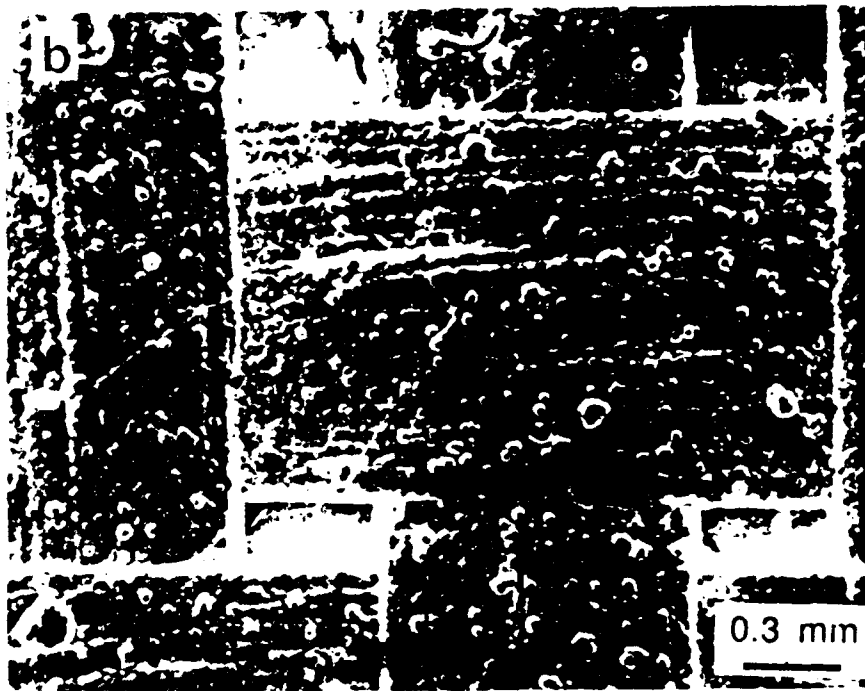
Figure 36. The same area as in figure 3 after the specimen was cycled for 150 cycles under a load range from 222N to 3782N. (a) and (b) are at different magnifications. The loading axis is horizontal.
